Ka 7

Handbook for sailplane

Schleicher K 7 "Rhönadler"

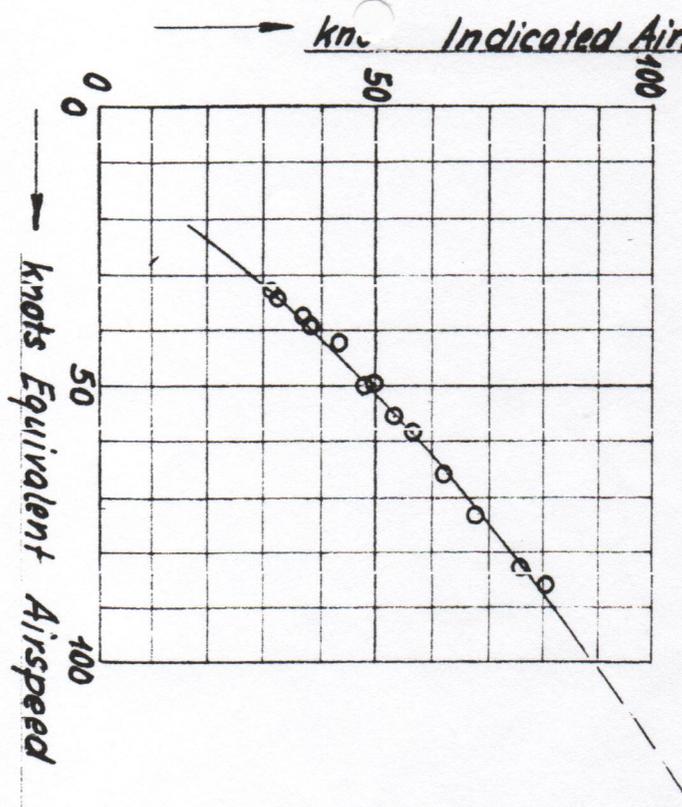
The data mentioned here are ascertained by calibration. They refer to the real flying speed (dynamic pressure EAS). There is still the position-error of the airspeed-venturi-head to be taken into consideration, which is dependent on the place the airspeed-venturi has been fixed. For the normal execution (venturi 3,5) in front on fuselage there is shown in fig 1. the position error in comparison with the real speed.

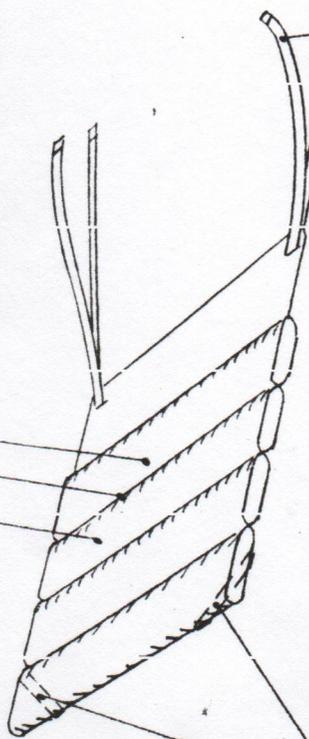
Heavy canvas.

Adjust size to seat

About 4 times separated.

Fill with lead shot or lead sheet stripes.

Webbing to hook in at the seat corners.

Heavy webbing to fix it on steel tubes or belt triangle.

With very light pilots in the front seat there is ballast necessary. It should be noted that this ballast is to be fixed to prevent blocking of the controls.

It is recommended to use a lead cushion prepared after the sketch below.

The weight of the ballast cushion should be 20 or 30 lbs. This weight is to be considered when using the trimplan.

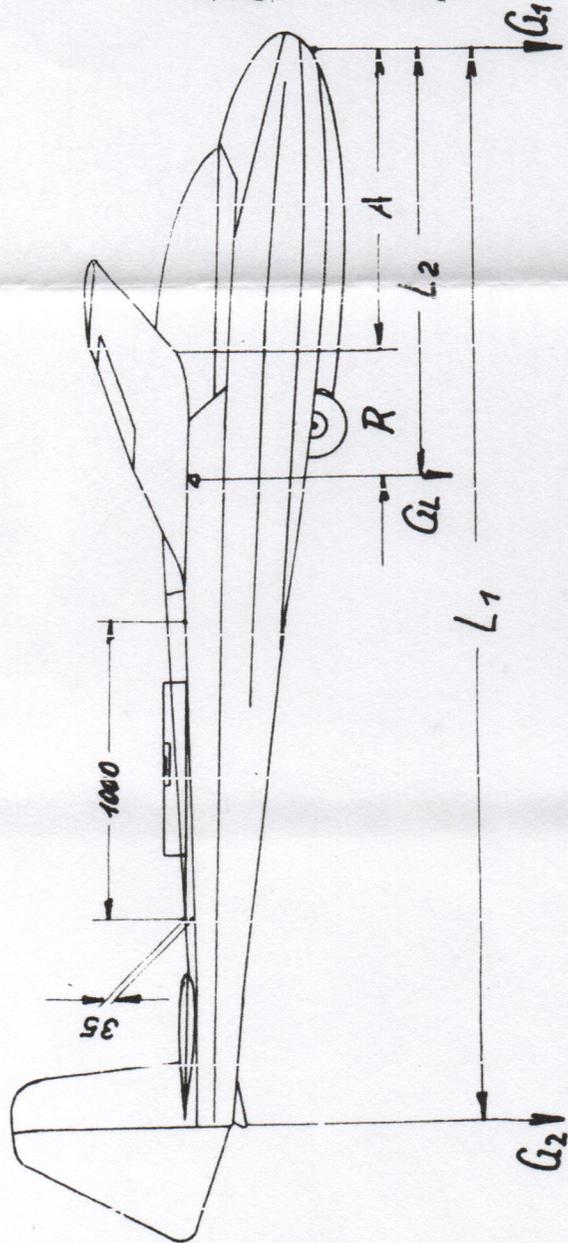
$$R - L_2 - A = \frac{G_2 \cdot L_1}{G_L} \dots A$$

$$G_1 + G_2 = G_L$$

hinter Flügelvorderkante Rippe 2
behind wing leading edge rib 2

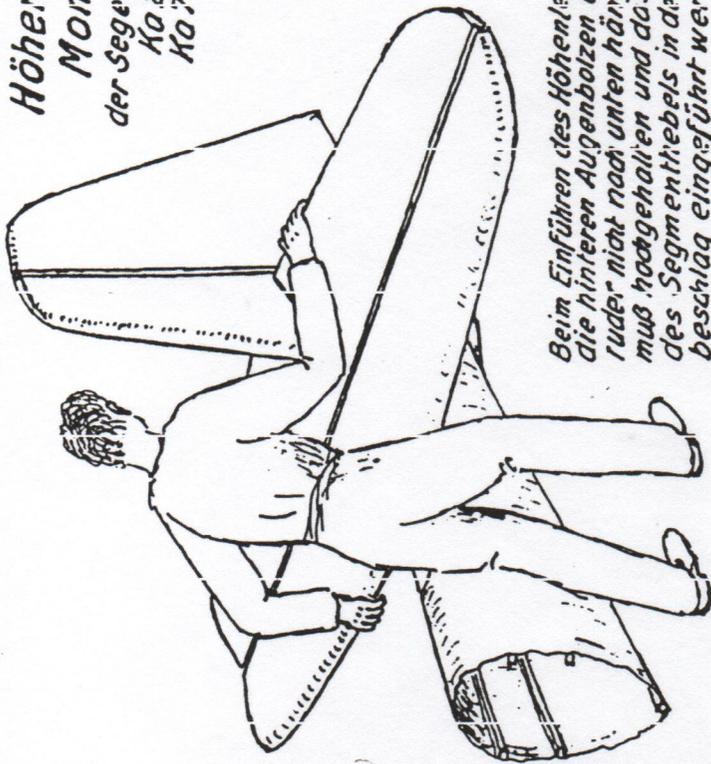
**Höhenruder-
Montage**
der Segelflugzeuge
Ka 2b, Ka 6,
Ka 7 und Ka 8.

Beim Einführen des Höhenleitwerkes in die hinteren Augenboizen darf das Höhenruder nicht nach unten hängen, sondern muß hochgehalten und das Kugellager des Segmenthebels in den U-Führungsbeschlag eingeführt werden!

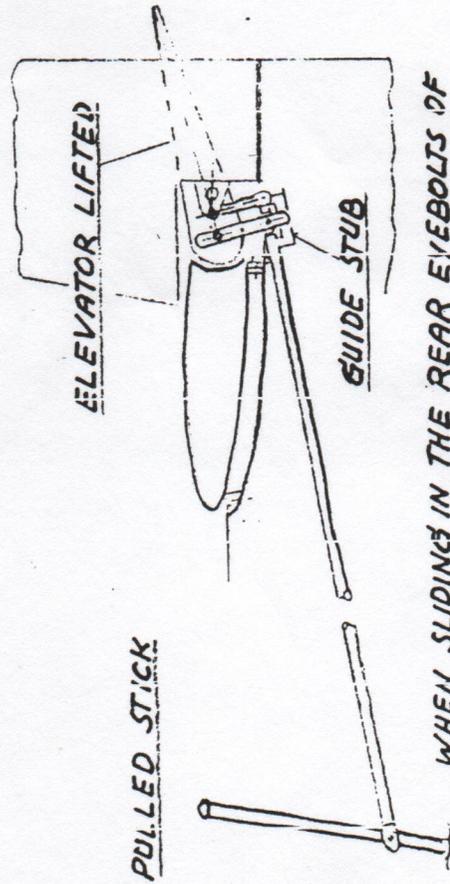
**ELEVATOR UNIT
ASSEMBLY**
SCHLEICHER K 8

WHEN SLIDING IN THE REAR EYEBOLTS OF THE STABILIZER IT IS ADVISABLE TO LIFT THE ELEVATOR SOMEWHAT. THE BALL BEARING OF THE ELEVATOR CONTROL LEVER MUST FIT INTO THE GUIDE STUB OF THE PUSH-PULL TUBE TO AVOID THE RISK OF BENDING THE TUBE.

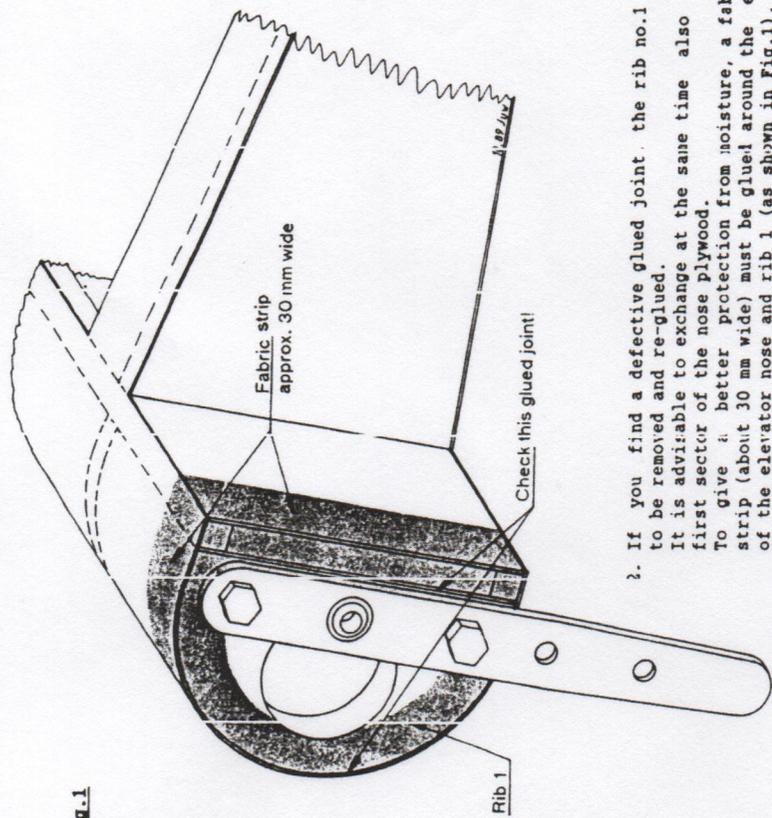
Fig.1

2. If you find a defective glued joint, the rib no.1 has to be removed and re-glued. It is advisable to exchange at the same time also the first sector of the nose plywood. To give a better protection from moisture, a fabric strip (about 30 mm wide) must be glued around the edge of the elevator nose and rib 1 (as shown in Fig.1).
3. The above action under points 1. and 2. must be repeated every three years during the annual re-inspection. This copy of the Technical Note must be inserted in the Flight and Operations Manual of the respective glider as an annex and a corresponding entry must be made into the "Amendments to the Manual".

Action:
1. Remove elevator.
Check that the glued joint between rib 1 and the leading edge plywood and the elevator spar respectively is in good condition (see Fig.1). Before doing so check whether the LTA 72-7 of Feb.9, 1972 was already previously accomplished (this is not applicable to K9, K11 and ASK 18); if yes then the fabric strip first carefully has to be detached in order to be able to check the glued joint.

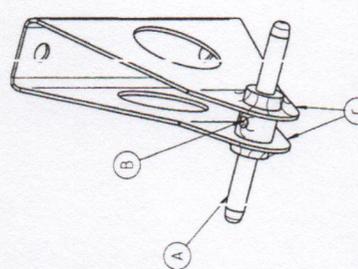
Fig. 1

Die Achse ist in einer Buchse geführt. Durch ein Loch (B) in dieser Buchse ist sie festgeschweißt. Diese Verbindung hat nicht mehr bestanden. On one glider it was found, that the axis (A) of the central support of the elevator was loose. (see fig. 1). This axis is supported in a bushing. Through a hole (B) in this bushing, the axis is fastened by a weld. This welded connection did not exist any more.

Dringlichkeit: Compliance	Vor der nächsten Jahresinspektion Before the next annual inspection	
Grund: Reason	Bei einem Segelflugzeug wurde festgestellt, daß die Achse (A) des Höhenruders lose war. (siehe Fig. 1) On one glider it was found, that the axis (A) of the central support of the elevator was loose. (see fig. 1). This axis is supported in a bushing. Through a hole (B) in this bushing, the axis is fastened by a weld. This welded connection did not exist any more.

Blatt 2 von 2	Technische Mitteilung für Technical Note for	Alexander Schleicher GmbH & Co. Segelflugzeugbau D - 36163 Poppenhausen
Maßnahmen: Action:	Das Höhenruder demontieren. Prüfen, ob die Lagerachse (A) fest sitzt. Dabei sind zusätzlich auch die Bleche des Lagerbocks rund um die Schweißnähte (C) auf Risse zu prüfen (mindestens mit einer Lupe 10-facher Vergrößerung). Gegebenenfalls ist der Lagerbock zu ersetzen. Diese TM ist als Anhang in das Flug- und Betriebsbuch einzufügen und im Berichtsungsstand einzutragen. Unround the elevator. Inspect the axis (A). It must have a firm seat. At that occasion, the sheet metal of the support is to be checked for cracks around the welds (C) (at least with a 10x magnification loupe). When indicated, the support must be replaced. This copy of the Technical Note must be inserted in the Flight and Operations Manual of the respective glider as an annex, and a corresponding entry must be made into the "Amendments to the Manual".
